## **NTM 04/16 East Loch Tarbert, Harris Sgeir Ghlas AtoN Light, A3993, All Sectors Unreliable**

**Date :** 5th January 2016

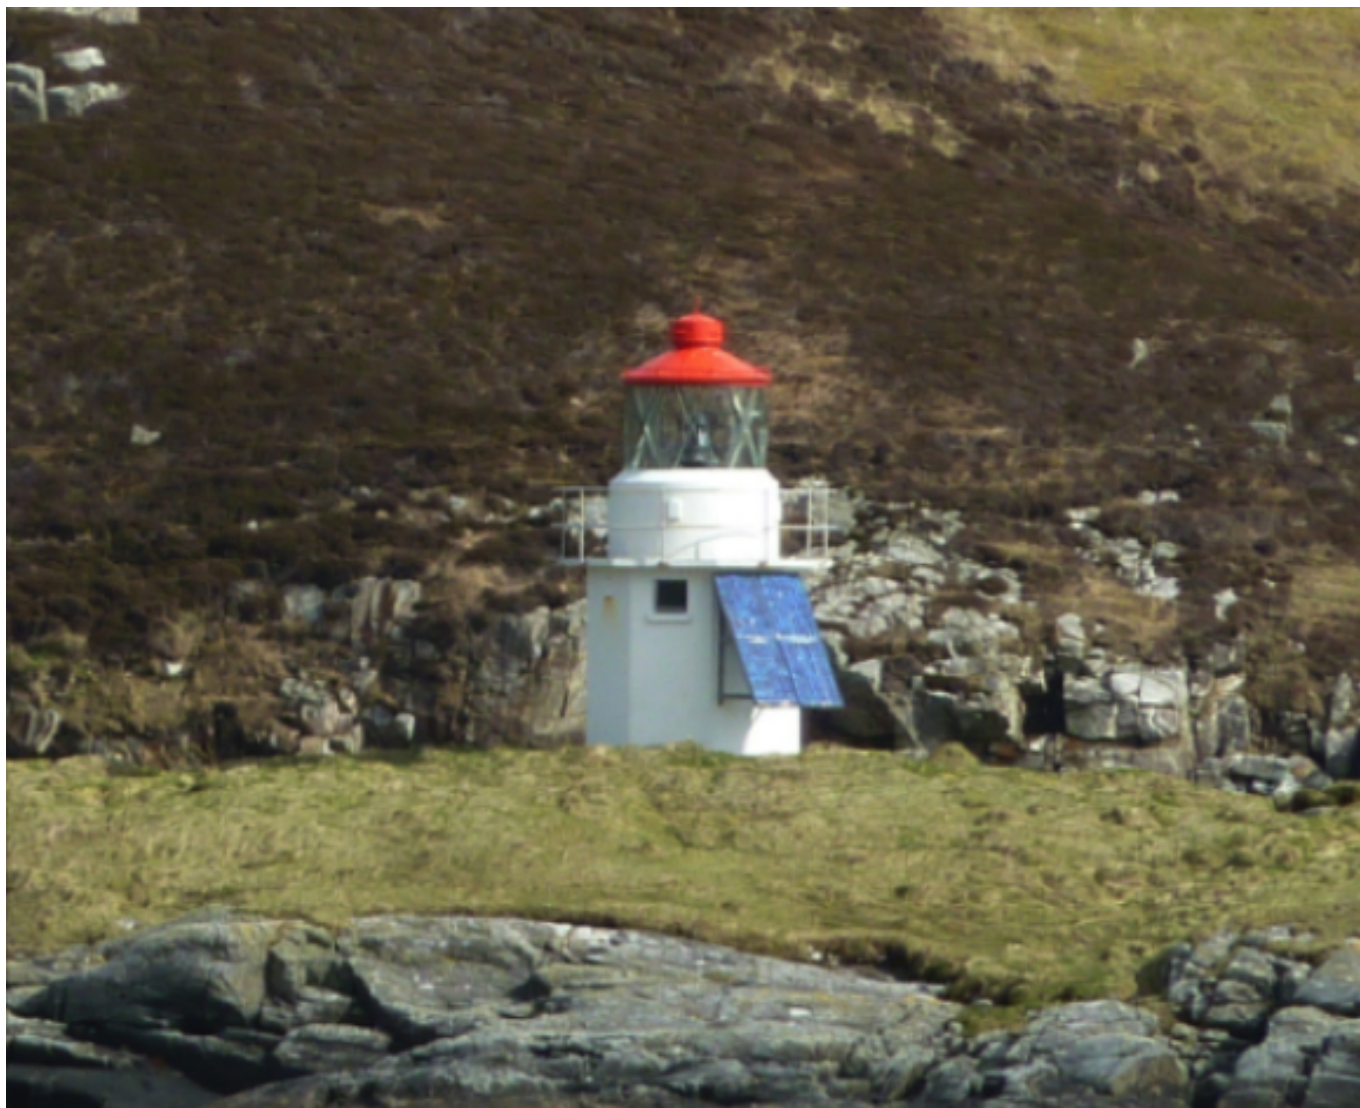
Mariners are advised that a recent inspection has discovered inaccuracies in all light sectors of Sgeir Ghlas sector navigation light.

Following an inspection by NLV Pharos it has been reported the southern (seaward) sectors were all found at 1 degree higher than charted while the northern (landward) sectors were 3 degrees higher. This sector light should therefore be considered by mariners to be unreliable.

The small lighthouse on Sgeir Ghlas, near Scalpay, East Loch Tarbert, consists of a stand-alone octagonal shaped concrete tower, which is painted white with a red roof.

Given the extremely exposed position of the light it is unlikely an attempt will be made to land to investigate further and rectify the inaccuracies until weather much improves.
