## **NTM 04/16 East Loch Tarbert, Harris Sgeir Ghlas AtoN Light, A3993, All Sectors Unreliable**

**Date :** 5th January 2016

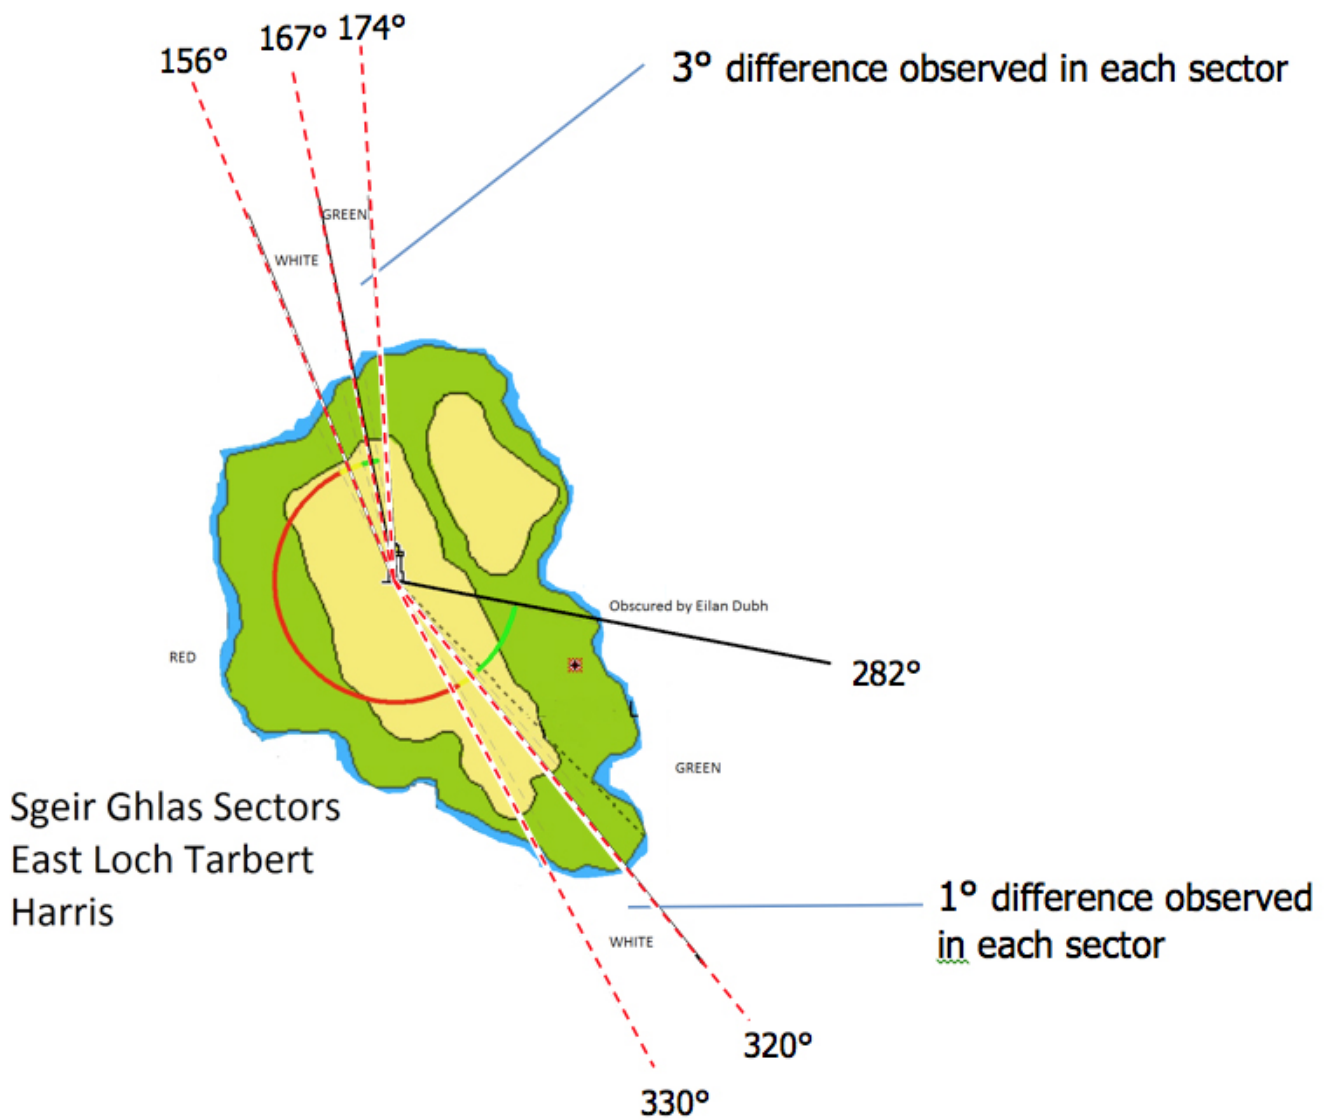
The observed sectors are as follows:

Following an inspection by NLV Pharos it has been reported the southern (seaward) sectors were all found at 1 degree higher than charted while the northern (landward) sectors were 3 degrees higher. This sector light should therefore be considered by mariners to be unreliable.

Given the extremely exposed position of the light it is unlikely an attempt will be made to land to investigate further and rectify the inaccuracies until weather much improves.
