NTM 04/16 East Loch Tarbert, Harris Sgeir Ghlas AtoN Light, A3993, All Sectors Unreliable

Date : 5th January 2016

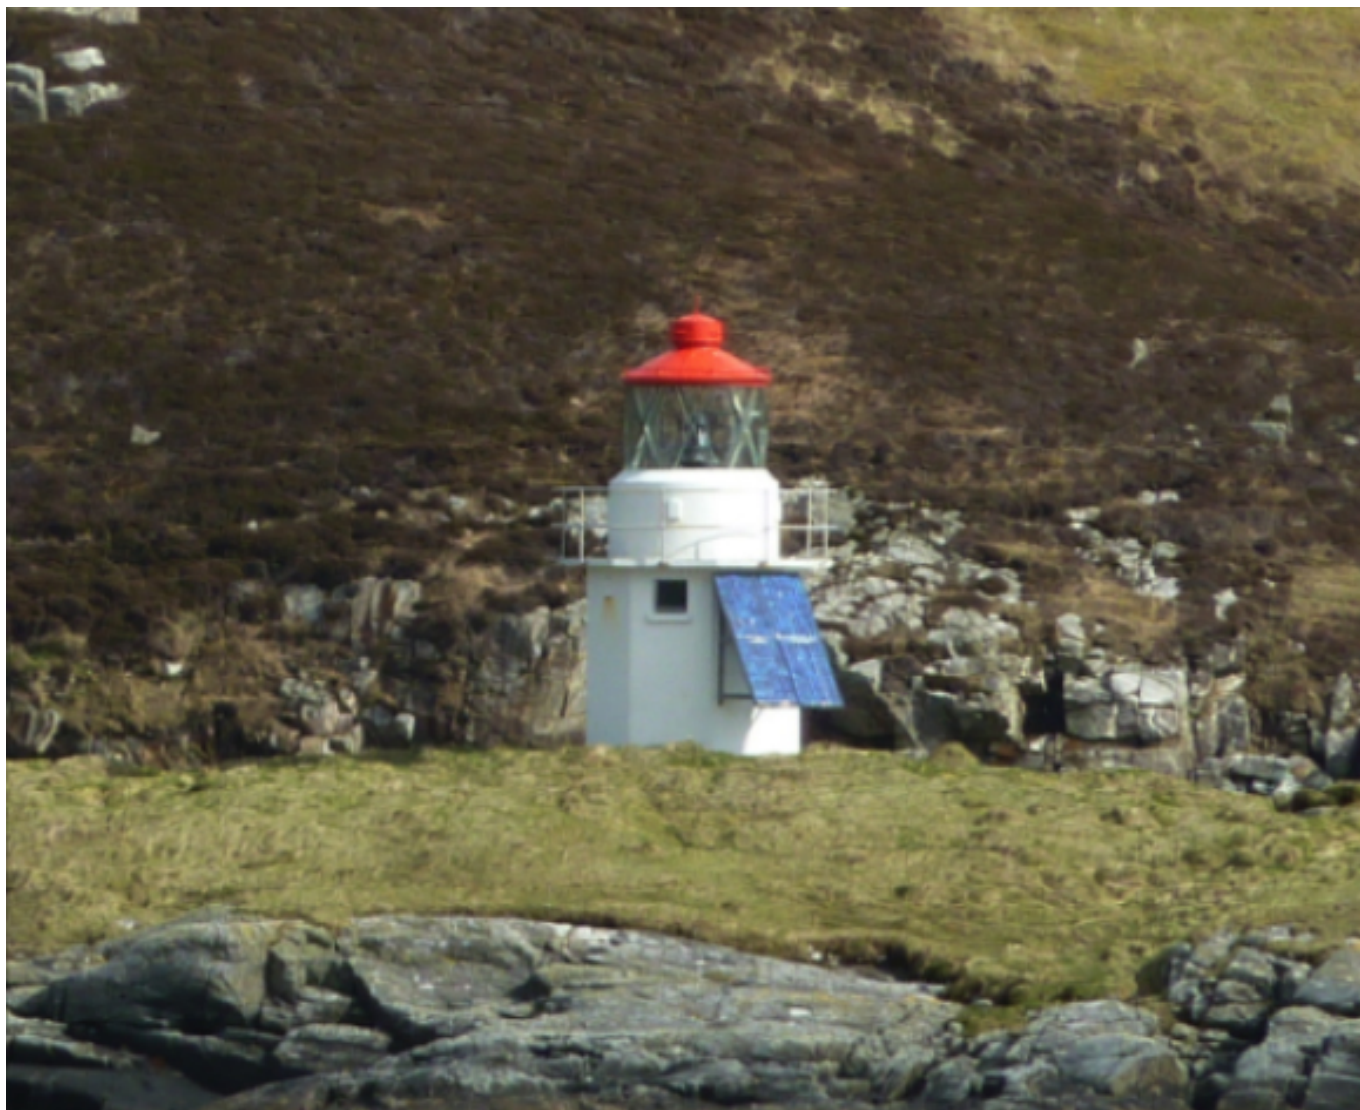
The small lighthouse on Sgeir Ghlas, near Scalpay, East Loch Tarbert, consists of a stand-alone octagonal shaped concrete tower, which is painted white with a red roof.

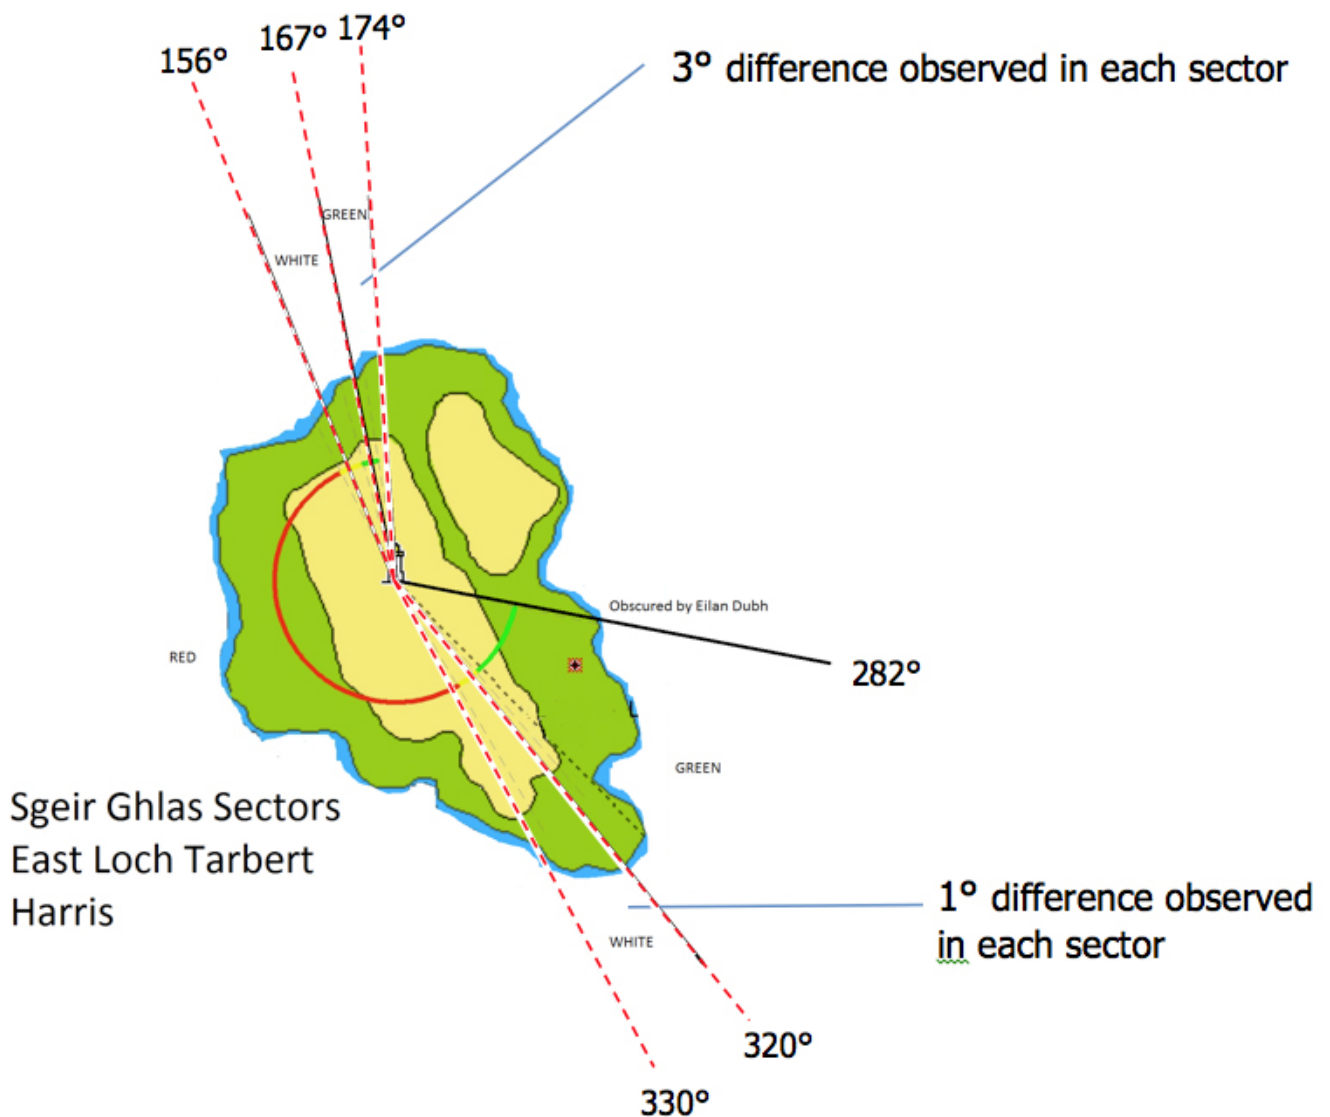
The observed sectors are as follows:

Following an inspection by NLV Pharos it has been reported the southern (seaward) sectors were all found at 1 degree higher than charted while the northern (landward) sectors were 3 degrees higher. This sector light should therefore be considered by mariners to be unreliable.

Given the extremely exposed position of the light it is unlikely an attempt will be made to land to investigate further and rectify the inaccuracies until weather much improves.
