NTM 79/18 Brodick Ferry Terminal Isle of Arran Linkspan Berth Fender Damage

Date : 28th August 2018

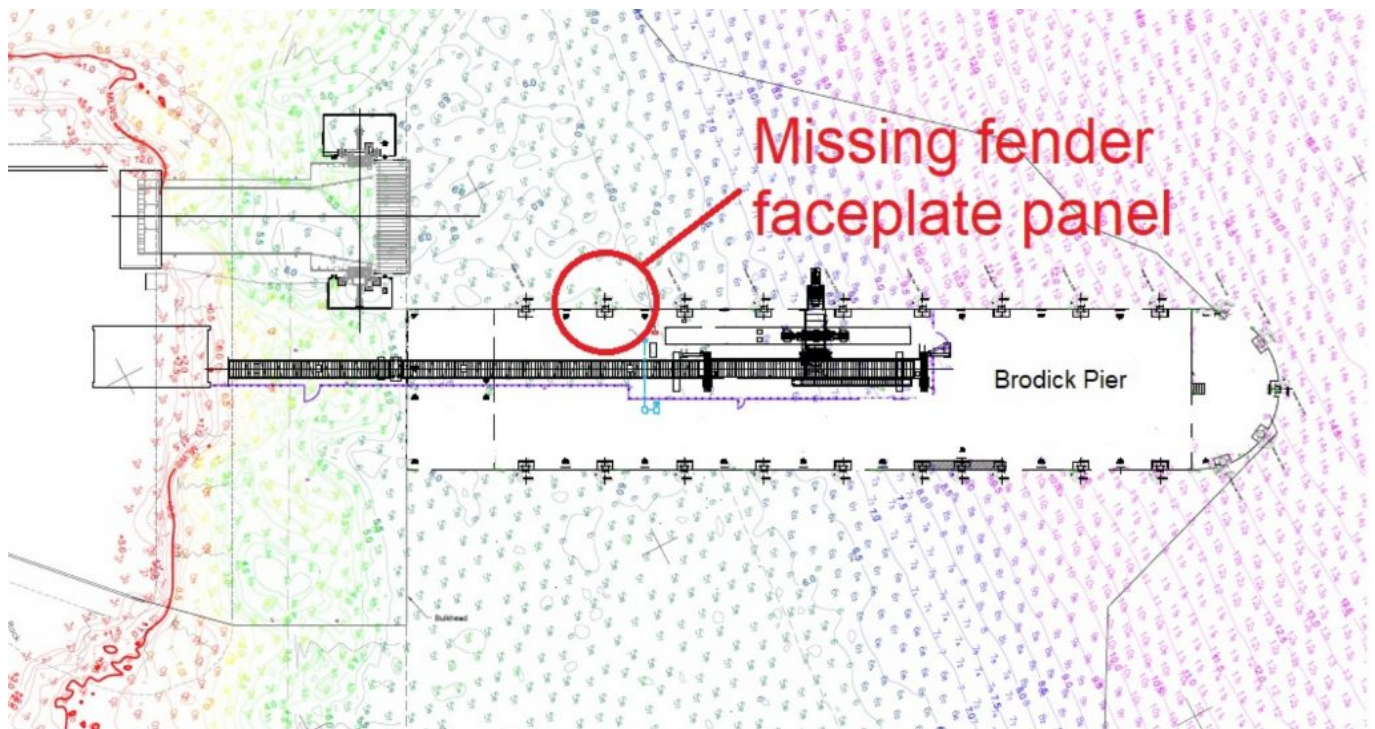
Mariners are advised that damage has been caused to a parallel motion fender located on the linkspan berth, Brodick Ferry Terminal, Isle of Arran, whereby a section of faceplate has become detached exposing the steel backing plate.

Until repairs to the fender can be undertaken and to avoid damage to vessels or the steel backing plate it is requested Mariners using the linkspan berth proceed with caution and minimise their berthing velocity in-so-far as prevailing conditions allow.
